LIMITED LEAD-BASED PAINT INSPECTION

**ELOY PRIMARY SCHOOL – CAMPUS ROOF RESTORATIONS AND BUILDING
WEATHERIZATION PROJECT**

1000 North Curiel Street
Eloy, Arizona 85131
WT Reference No. 2188JH269

August 8, 2018

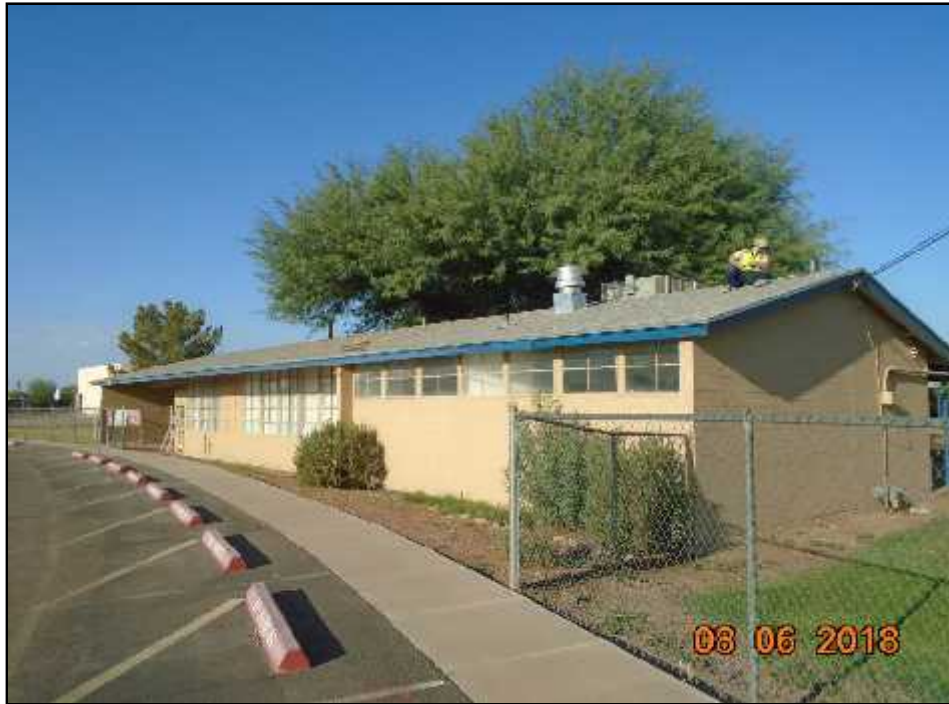
Picture 1 – East side exterior of Building 5 (RPA Building H).

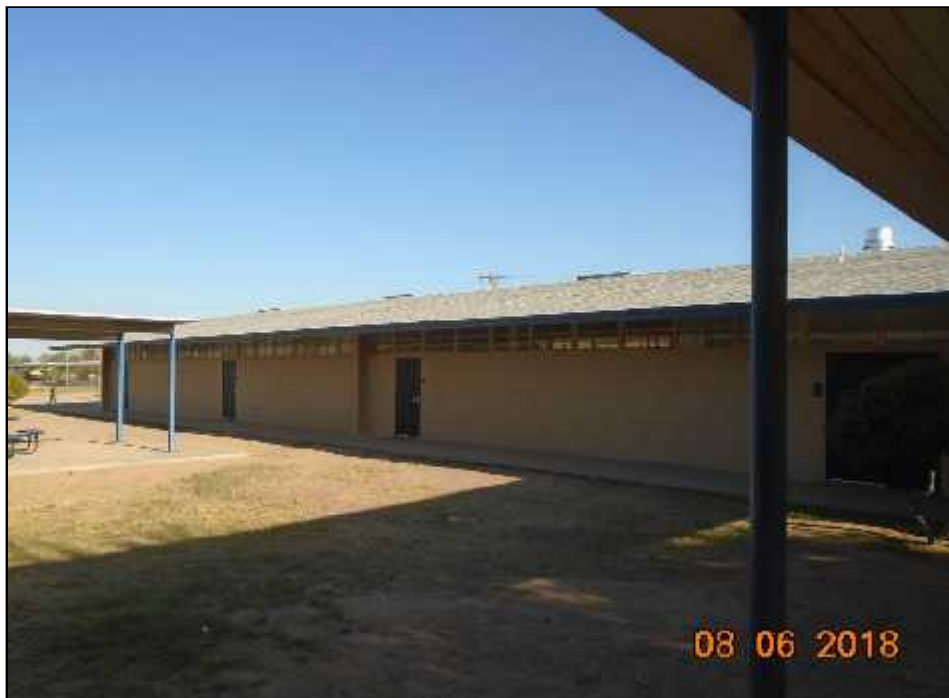
Picture 2 – South side exterior of Building 6 (RPA Building A - West).

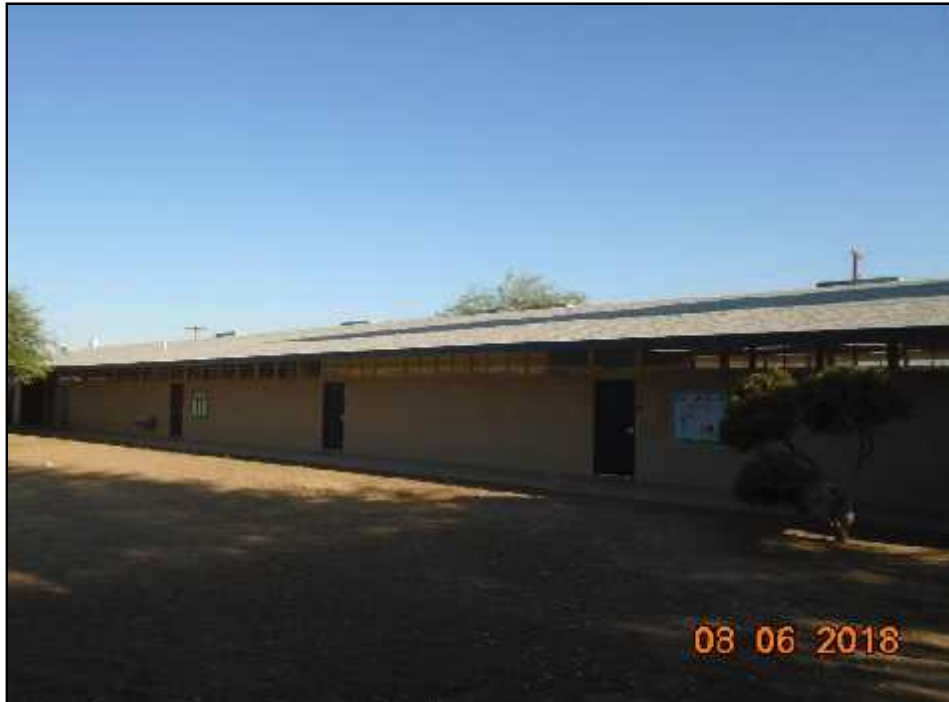
Picture 3 – South side exterior of Building 7 (RPA Building A – East).

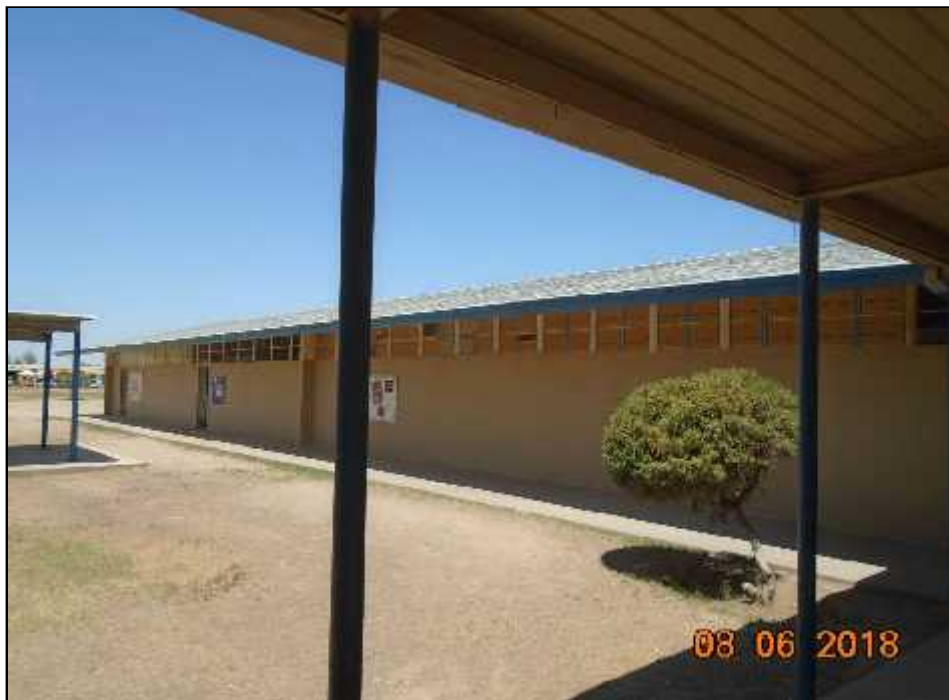
Picture 4 – South side exterior of Building 8 (RPA Building B – West).

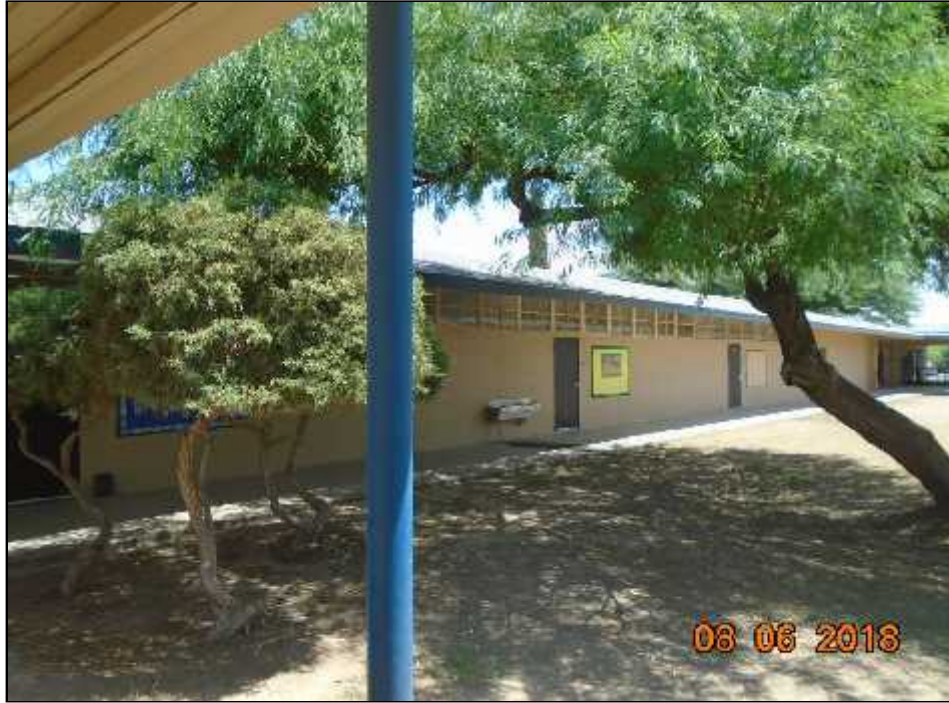
Picture 5 – South side exterior of Building 9 (RPA Building B – East).

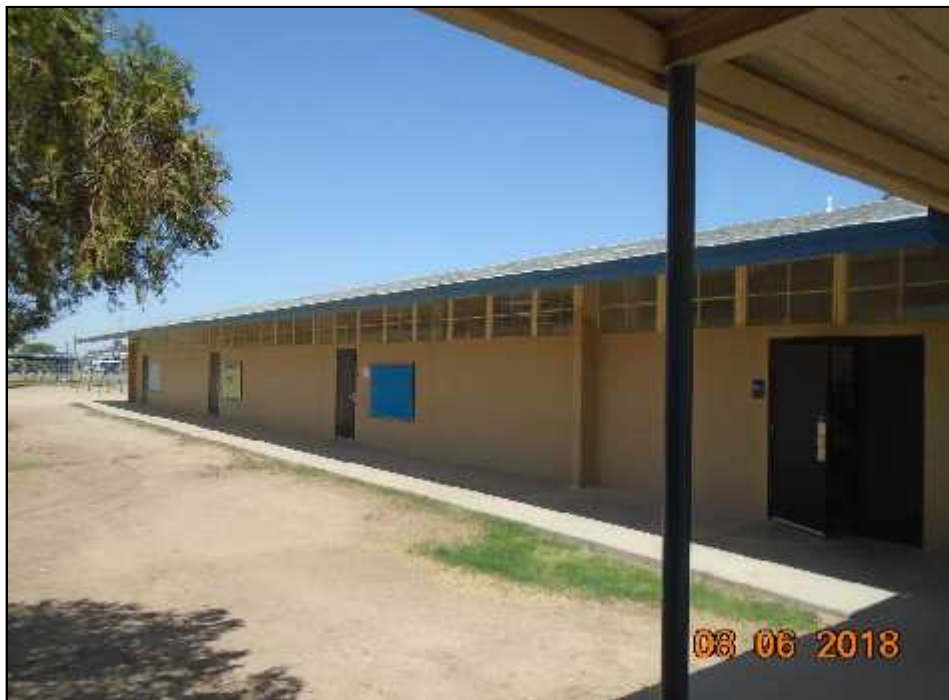
Picture 6 – South side exterior of Building 10 (RPA Building C – West).

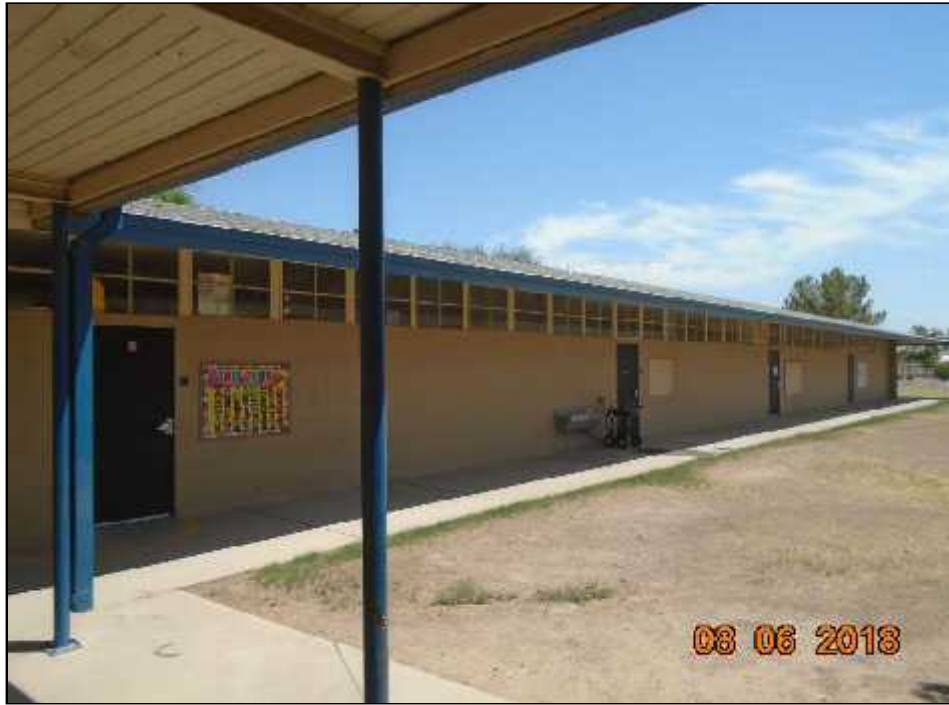
Picture 7 – South side exterior of Building 11 (RPA Building C – East).

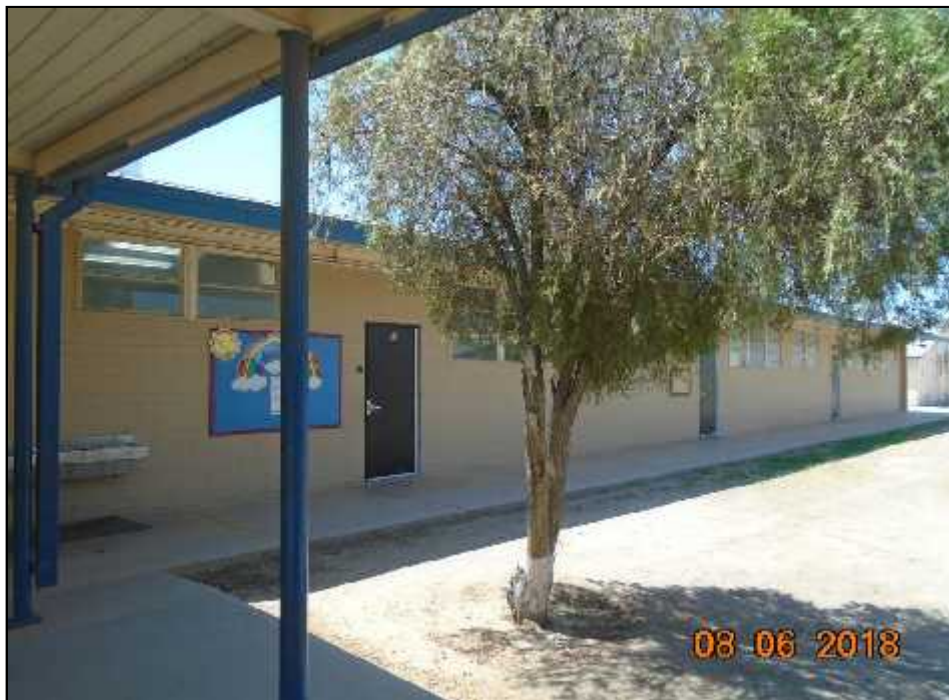
Picture 8 – North side exterior of Building 12 (RPA Building D – West).

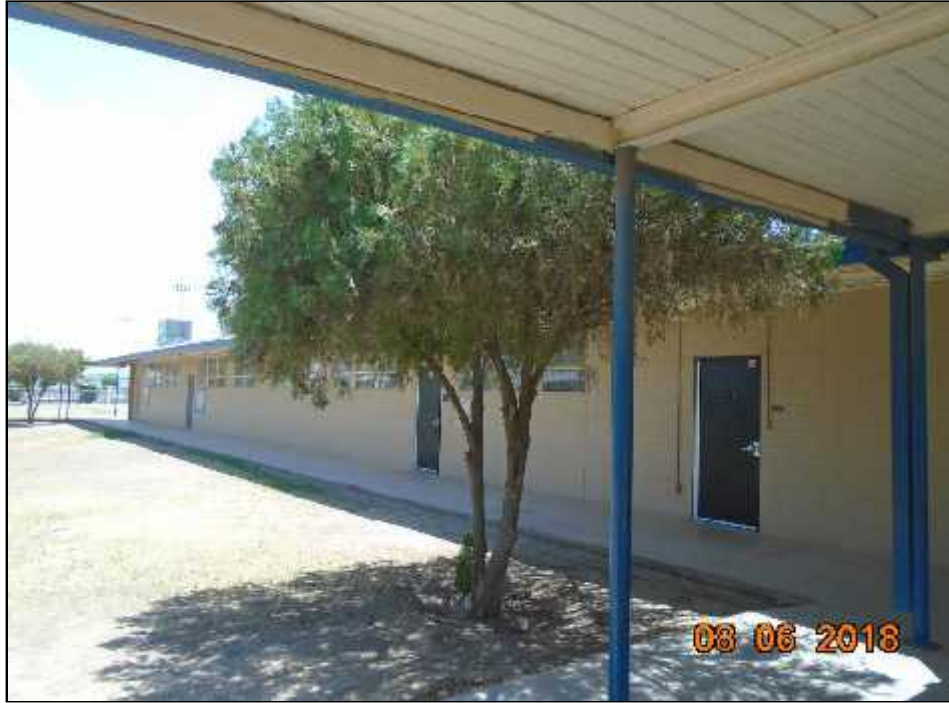
Picture 9 – North side exterior of Building 13 (RPA Building D – East).

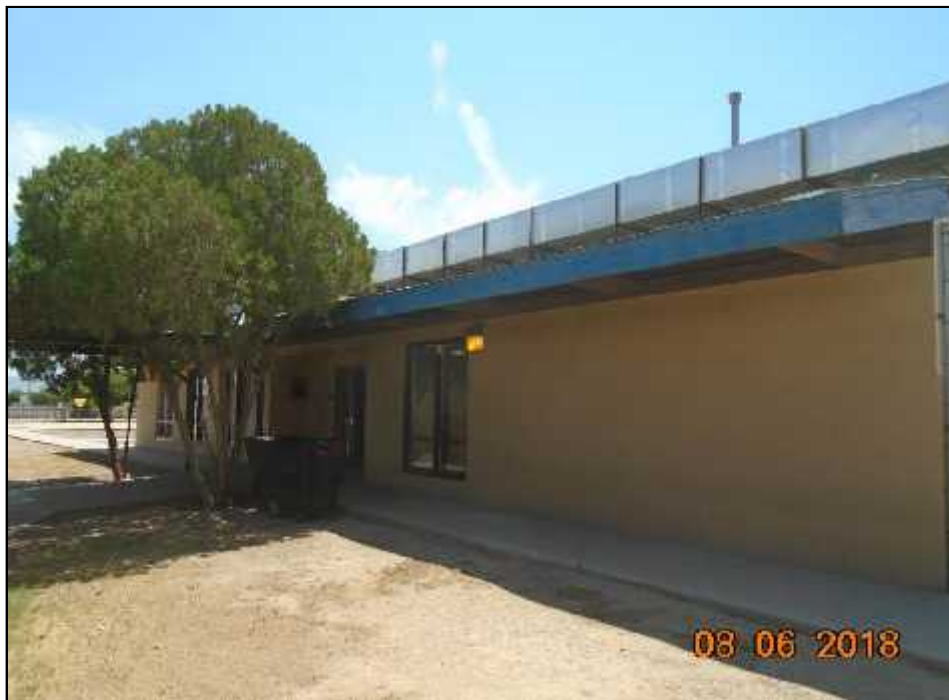
Picture 10 – North side exterior of Building 14 (RPA Building F).

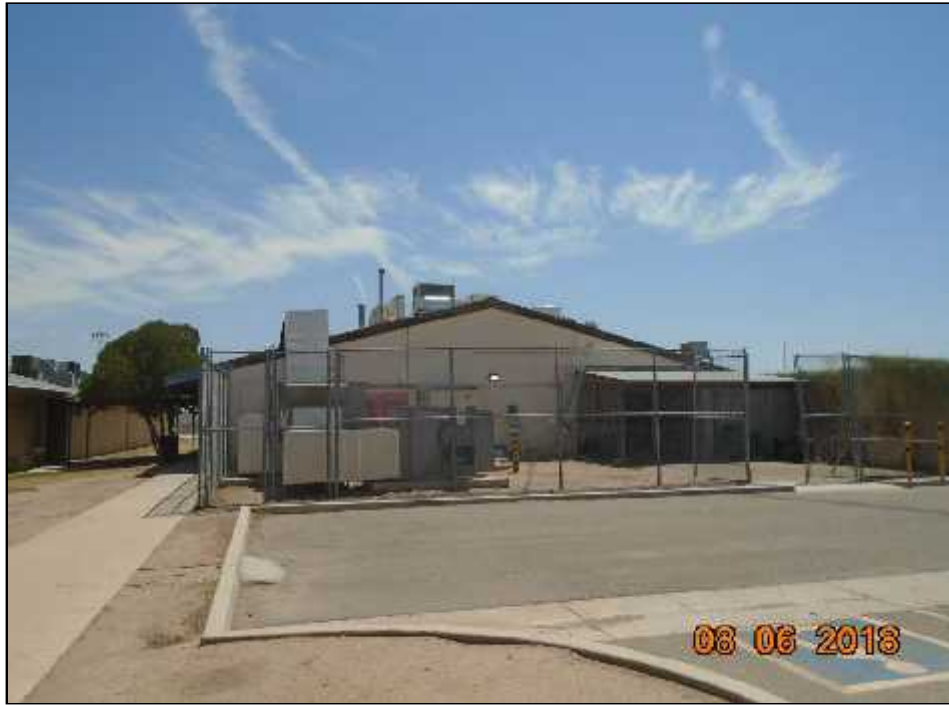
Picture 11 – West side exterior of Building 14 (RPA Building F).

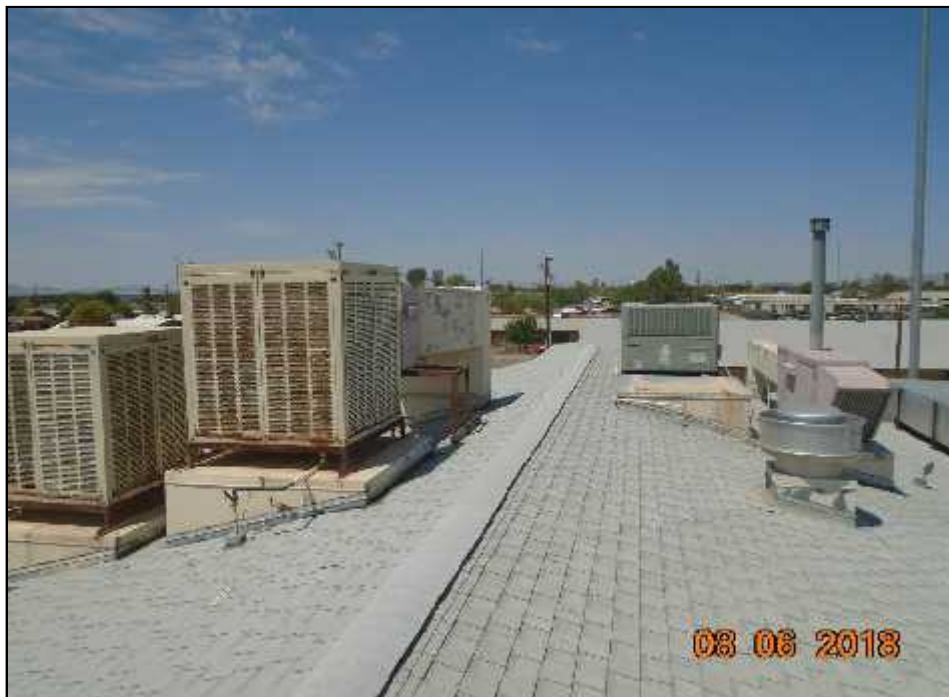
Picture 12 – Roof of Building 14 (RPA Building F).

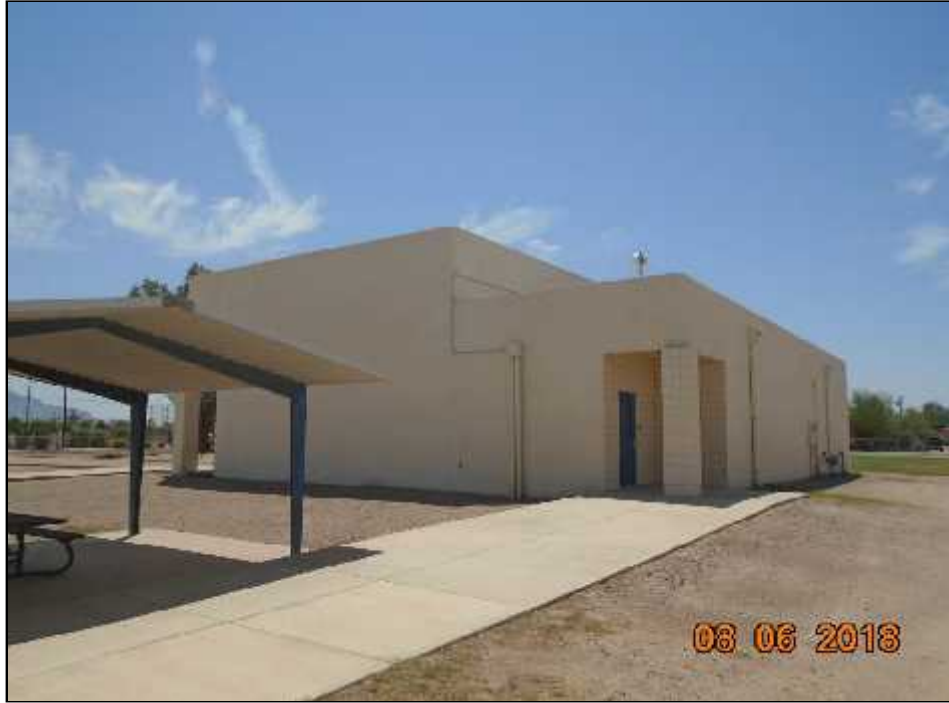
Picture 13 – South side exterior of Gymnasium (RPA Building G).

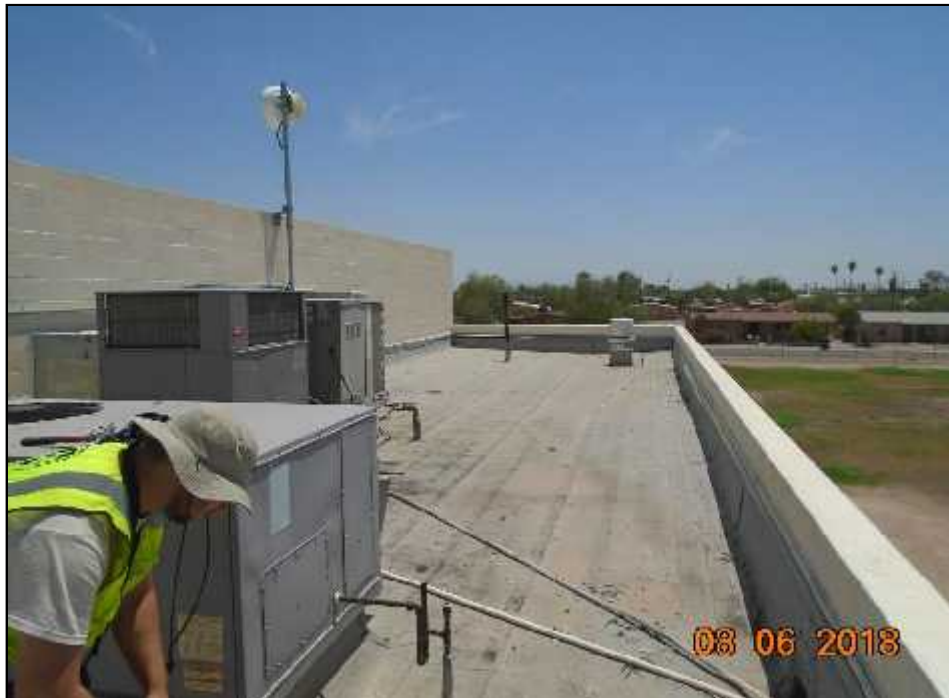
Picture 14 – Roof of Gymnasium (RPA Building G).
